SAFETY RECALL NOTICE

WORKHORSE CUSTOM CHASSIS SERVICE BULLETIN

BULLETIN NO: 20601-C

SUBJECT: Steering Intermediate Shaft

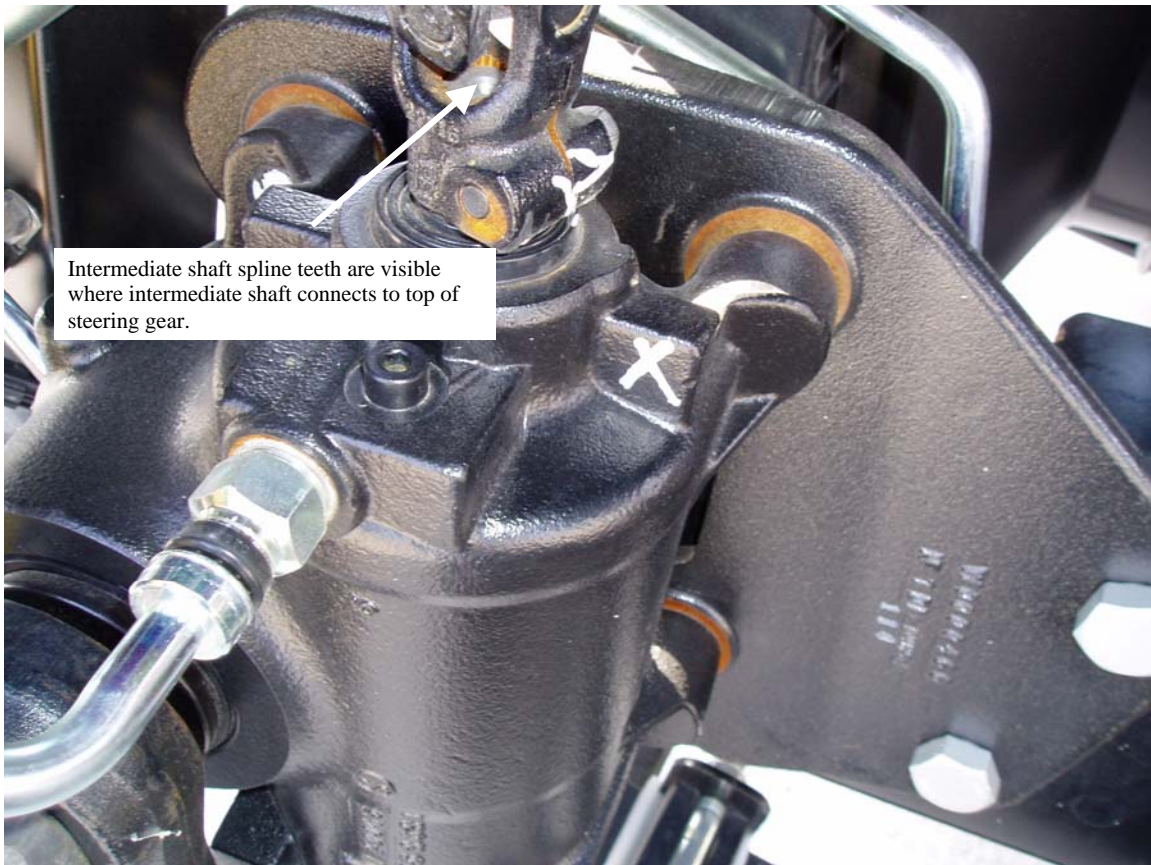
Inspect the intermediate shaft where it is connected to the input shaft at the top of the steering gear. The spline on the intermediate shaft is visible above the tip of the steering gear input shaft, as indicated in the photograph below:

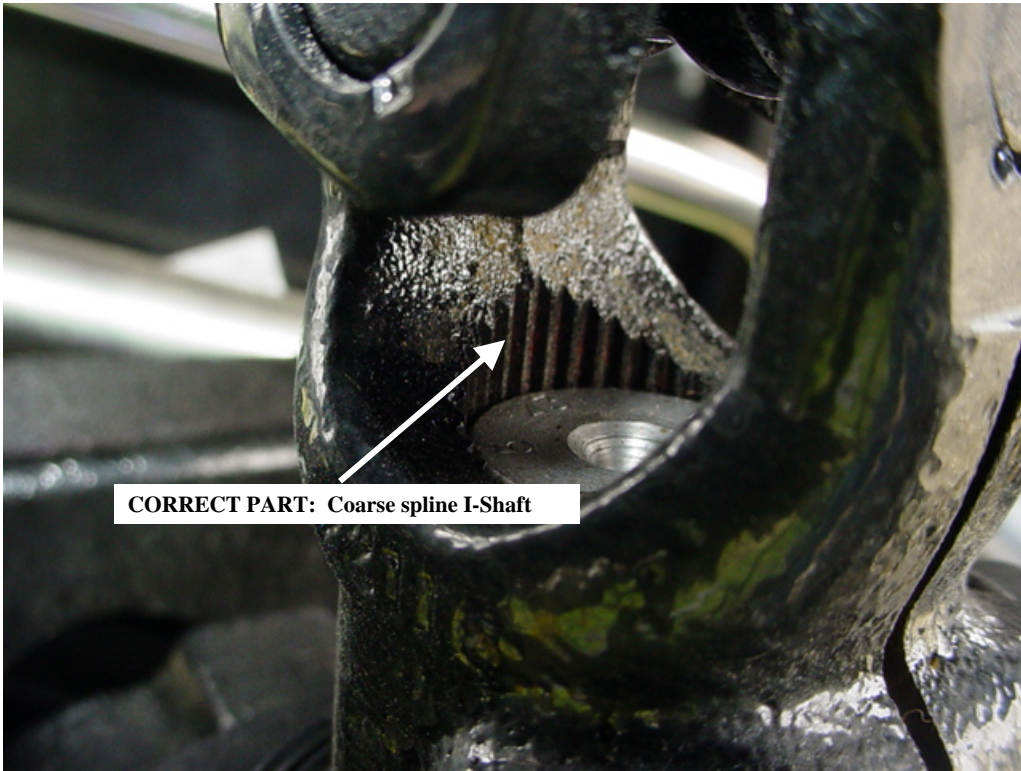
CORRECT PART: Coarse spline I-Shaft

The coarse spline I-shaft is shown above. This is correct for W20/22/24 models.

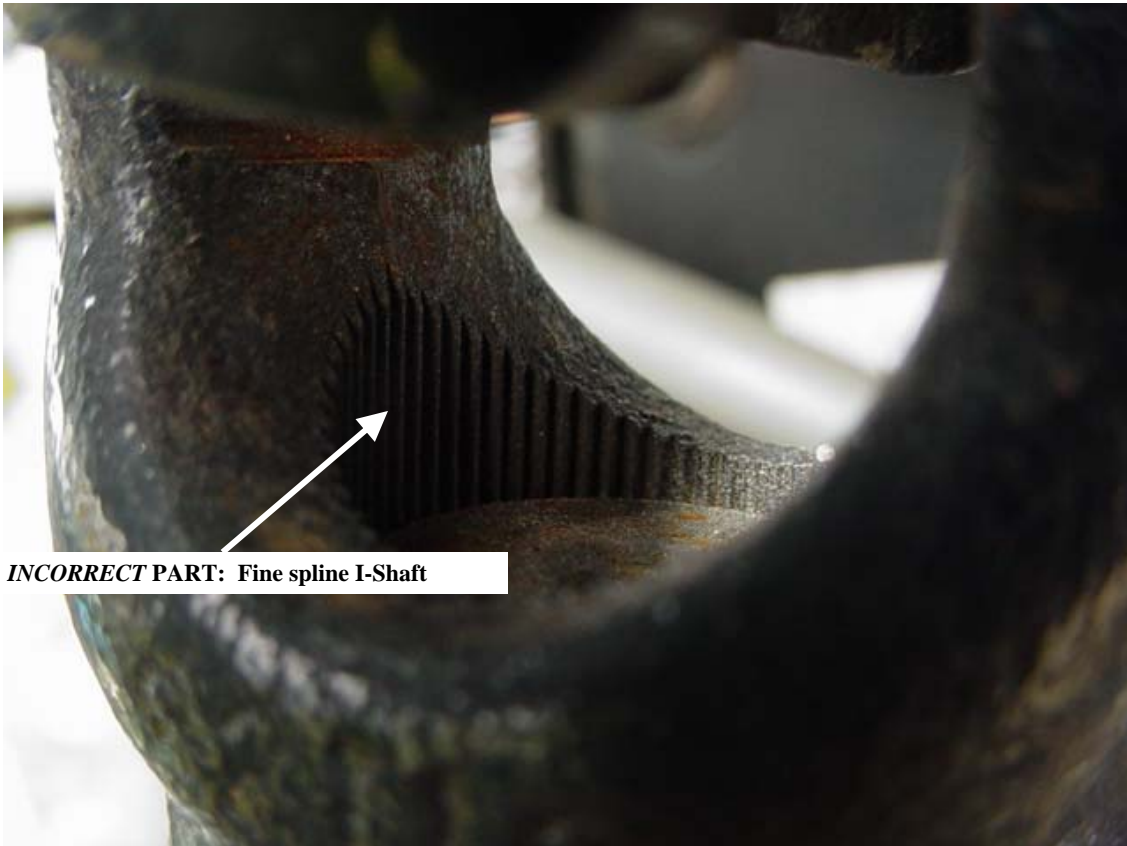
INCORRECT PART: Fine spline I-Shaft

An incorrect steering intermediate shaft may have been installed on some of the subject chassis during the relevant production period. The incorrect part (W0007621) has a finer pitch spline than the correct part (W0000450). Use of the incorrect part may cause the spline not to match correctly with the corresponding steering gear input shaft. On vehicles equipped with the incorrect part, the spline can strip if the steering wheel is turned with a significant amount of force. The force required to strip the spline (i.e., steering wheel input of 10 to 90 ft-lbs of torque) is more than ordinary users will experience. This failure is likely only to occur when the vehicle is stopped or during tight turning maneuvers at very low speeds. This condition may result in a loss of steering control.

The fine spline I-shaft is shown above. This is *incorrect* for W20/22/24 models.

The service procedure for this recall requires inspection of the steering intermediate shaft to determine if the correct part was installed (as shown in the attached Inspection Procedure). If an incorrect shaft is identified, it should be replaced with the correct part (Part Number W0000450). Torque pinch bolt to 36-40 ft-lbs.
