## **WORKHORSE CUSTOM CHASSIS SERVICE BULLETIN**

**BULLETIN NO:** 60601-C Revised

**SUBJECT:** 8.1 L Engine Fuel Rail Damper Retainer Clip

**MODELS:** 2004, 2005 and certain 2006 W20, W22, W24, P32, W52, W18 and FE20 models with 8.1L Gasoline Engine

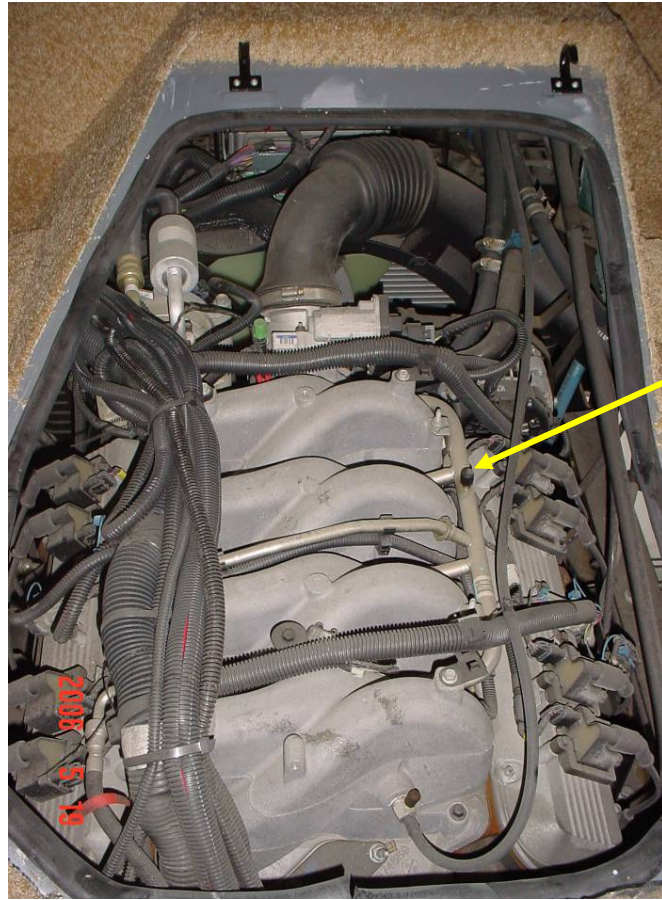
**Photo 1 Black cap on pressure valve on fuel rail on top RH side of Engine**

1. Turn off engine and have ignition key in off position.
2. Remove engine cover to gain access to fuel rail on left side top of engine.
3. Disconnect the negative battery cable.
4. Loosen the fuel filler cap in order to relieve the tank vapor pressure.
5. Relieve any residual fuel pressure through the fuel pressure connection valve shown by photo 1 using a fuel pressure gage, or equivalent, and an approved fuel container. Wrap a shop towel around the fitting while connecting the gage in order to avoid spillage. To assist in relieving the residual pressure in the fuel rail, push down on the fuel rail damper. The damper should move inwards slightly as the pressure releases from the system.

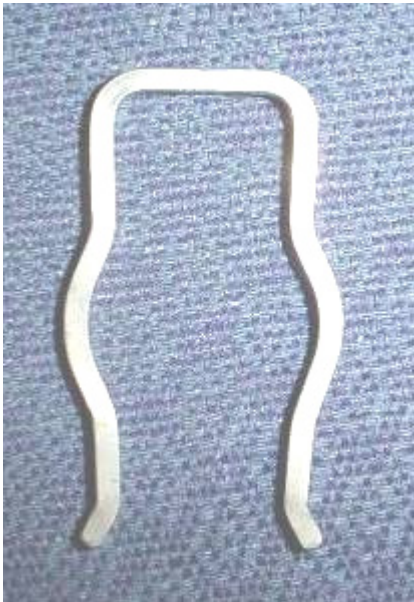
**Photo 2 Retaining clip**

6. While continuing to push down on the fuel damper use a flat screwdriver to remove the existing clip. (See photos 2 and 3)  
**NOTE:** If fuel pressure is not relieved as directed by step 5, or the damper is not held in position during the replacement of the retainer clip, the damper O-Ring can be mis-positioned by the system pressure or by unseating itself in the case of not being held down in place or there may be dirt entry resulting in a fuel leak. It will be necessary to clean the damper O-ring seat area and inspect/replace the O-ring and reinstall damper into O-ring after it has been properly placed in the fuel rail.

7. Do not remove the fuel damper from the fuel rail. If the damper is removed the fuel damper o-ring must be replaced.
8. While holding down the damper, install the new clip in same position as removed clip.

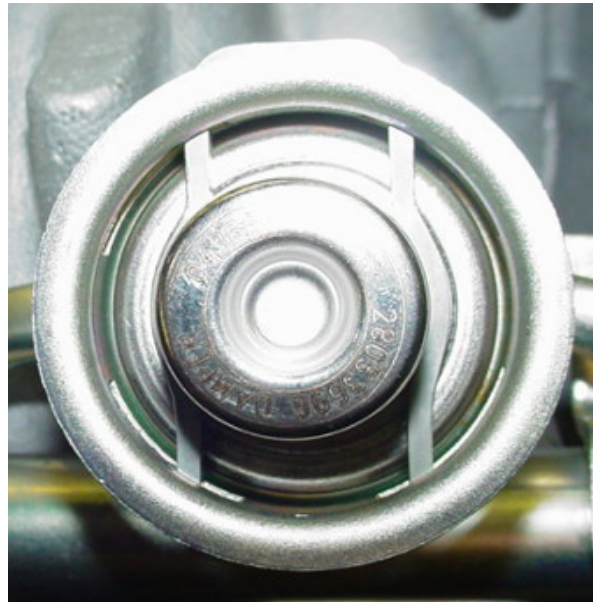
**Photo 3 Damper held by retaining clip**
